STANFORD UNIVERSITY
STANFORD, CALIFORNIA 94305-4085
GRAVITY PROBE B RELATIVITY MISSION

GYROSCOPE CAGING MALFUNCTION FAULT TREE ANALYSIS

S0674 Rev A
February 14, 2003

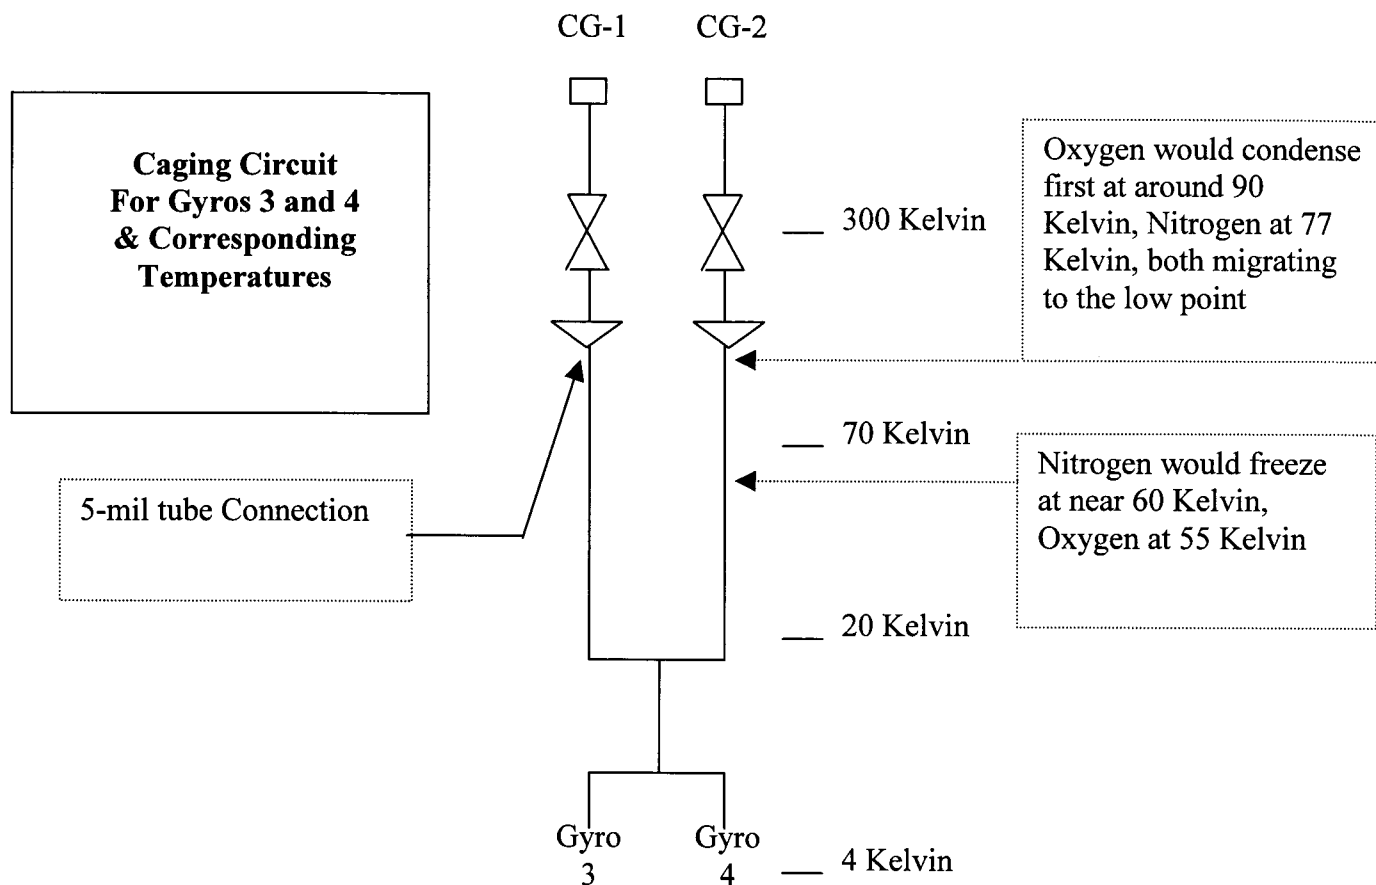
Figure 1: Caging Circuit Geometry

The figure below depicts the geometry of the caging line for the Gyro 3/4 circuit. This line can be pressurized via two access points: CG1 and CG2. These two lines form the top of a “Y” which joins further down the probe. The caging circuit is single string for a length, and then it divides again at the base of the quartz block to go to Gyro 3 and Gyro 4.

The lines at the top are relatively large in diameter, roughly 3/8 of an inch. However, in order to avoid thermal acoustic oscillations in the lines, they are gradually staged down. Inside the vacuum can, the lines have a 5 mil ID.

Note that the union of the two access lines to the caging circuit occurs at a location, which is less than 20 Kelvin when the probe is inserted in the Dewar. This was done intentionally so as to assure that any air that leaked in would freeze in the section of tubing above the joint in the temperature range of about 60 to 20 degrees Kelvin and not cross contaminate from one line to the other.

Since gas will tend to condense at the coldest portion of the line, which is located at Station 200 during probe insertion, there is a strong tendency for the line to form an ice block in a single place. This makes this failure mode more likely than the multiple ice block fault discussed in 2.1.2.3.2. However, based strictly on the observable data, it is impossible to differentiate between this single ice block mode and the multiple block failure mode given in 2.1.2.3.2.

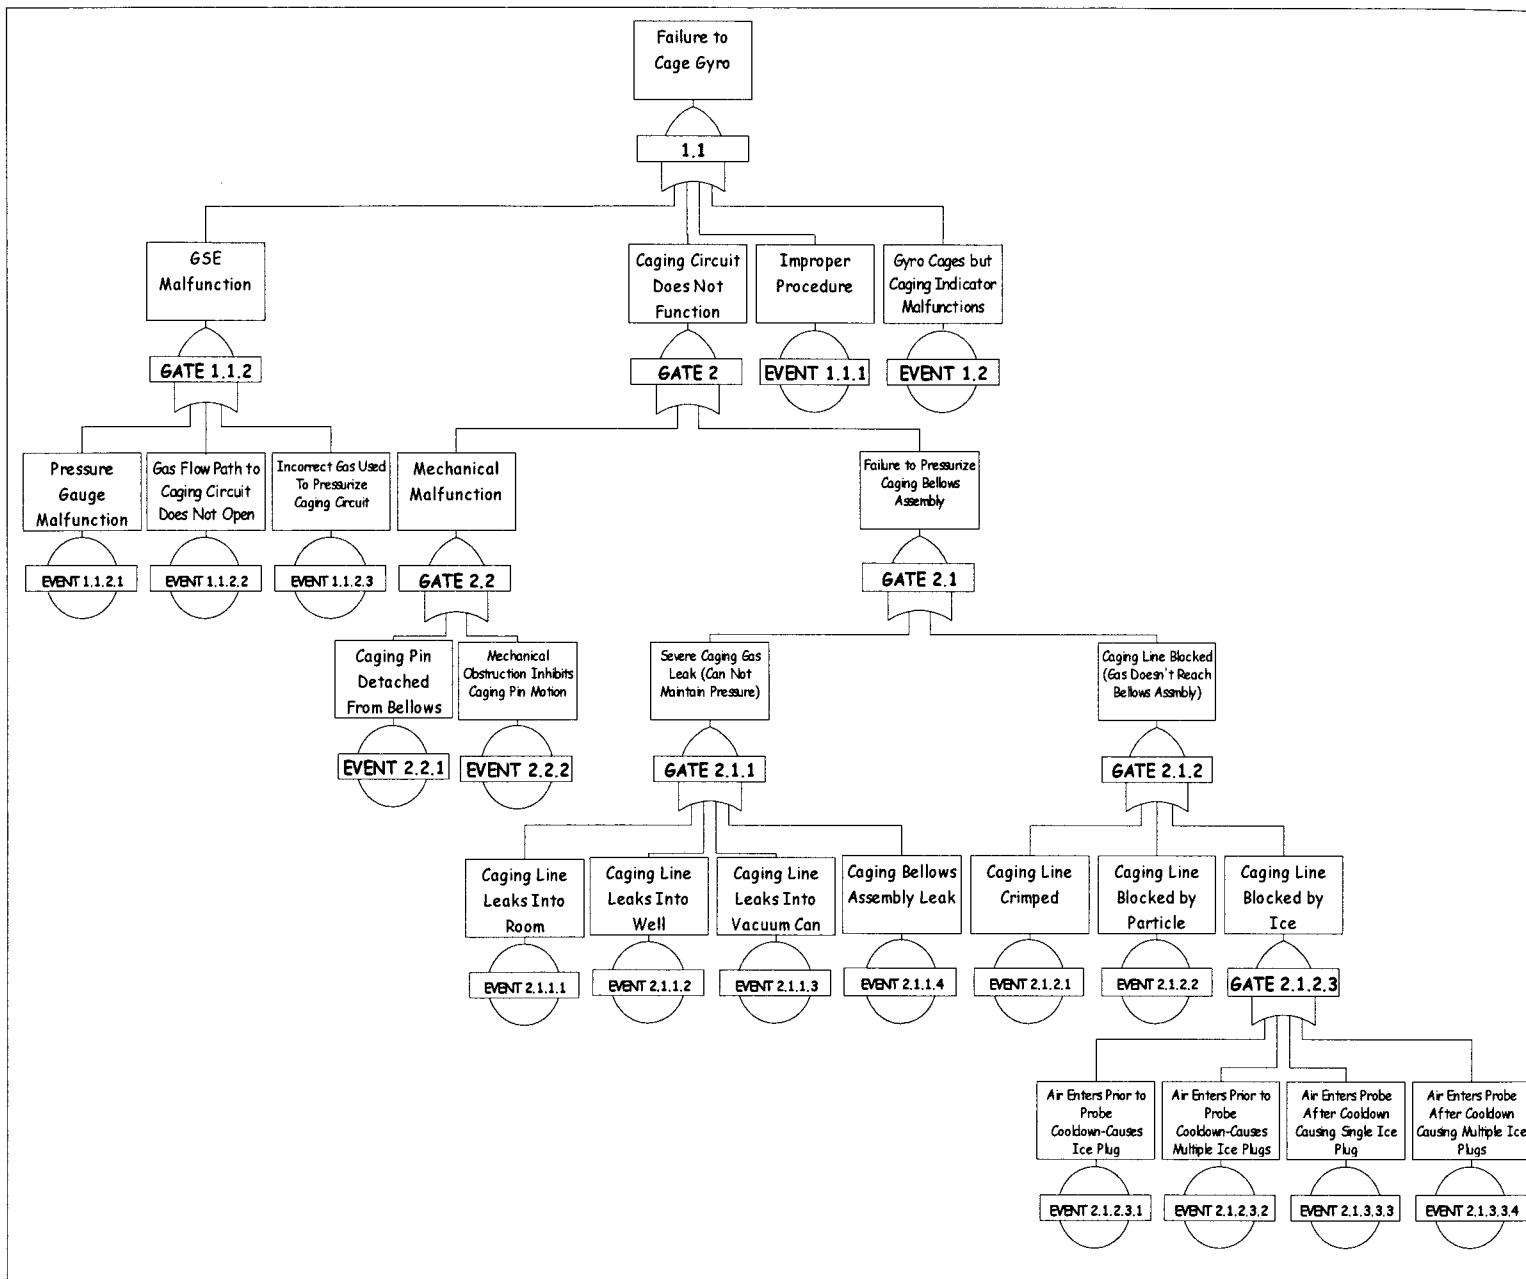
Section G: Fault Tree Block Diagram

A complete fault tree analysis was performed on the caging anomaly. The root cause was found to be an ice plug in the line, formed by air that entered the line prior to the probe's insertion into the flight dewar. It was further found that the plug would remain stable throughout the science mission, and there is no credible mechanism for an inadvertent caging of the gyroscope. On-orbit contingencies were also addressed for each of the nodes in the fault tree.
