Gravity Probe B Program Procedure No. P0834 Rev. -Operation Order No. _____

GRAVITY PROBE B

GSE INSTALLATION

MOCK THRUSTER VENT PALLET INSTALLATION AND LEAK CHECK

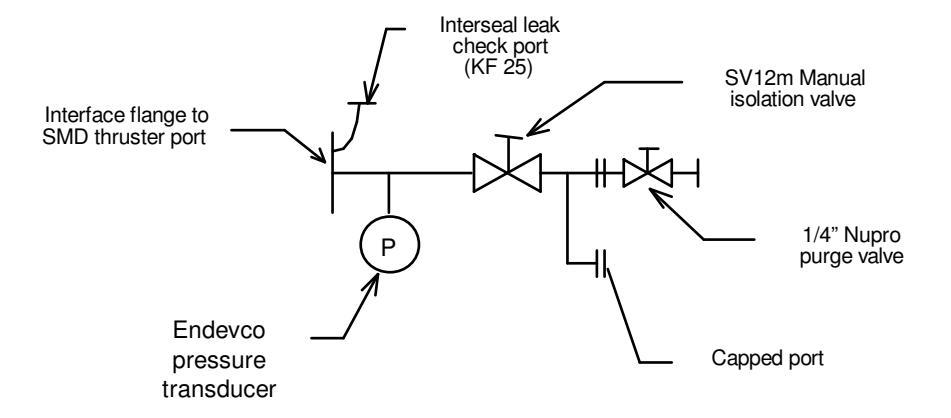
Figure 1. Schematic of MTVP

This procedure effects the installation and leak check of the Mock Thruster Vent Pallet. It is mounted onto the upper cylinder portion of the SMD and is connected to the SMD thruster vent port. The MTVP is intended to simulate the equivalent flight plumbing in its prelaunch condition but does not provide any functionality except as a location for a pressure transducer to monitor the Main Tank pressure. See 65113-5833500 for a drawing of the flight assembly.

Description	No. Req'd
MTVP Ass'y with Endevco 8510C-50 (50 psig) pressure transducer (see Fig. 1)	1
#2 rubber stopper	1
Helicoflex seal 5833463-107 (existing seal, if installed, may not be reused)	1
Viton o-ring 2-030V747-75 (existing o-ring may be reused, if present)	1
10-32 x0.500" socket head cap screws (A286 CRES); reuse existing hardware	8
#10 stainless washers; reuse existing hardware	8
1" or 1.5" stainless flexible pumping line (length A/R)	1

••••••	Appropriate a riterinearien
0	Verify SU QA program office notified.
Re	ecord: Individual notified,
Da	ate/time/
0	Verify ONR representative notified.
Re	ecord: Individual notified,
Da	ate/time/
Bench	leak check the MTVP (see Fig. 1):
L.3.1	With the test port blanked off, start up the leak detector per manufacturer's instructions.
L.3.2	Perform LD autocal (model 960) or manually check LD tuning.
L.3.3	Turn on LD calibrated leak and record:sccs He
	Calibrated leak value:sccs He
	QA witness:
L.3.4	Turn off the calibrated leak and vent LD.
L.3.5	Clean the #2 rubber stopper and insert in the center hole of the MTVP thruster port interface flange.
L.3.6	Connect a pumping line from the LD test port to the MTVP purge valve.
L.3.7	Open both SV12m and the purge valve on the MTVP.
L.3.8	Bag the MTVP.
L.3.9	Start LD and apply He to the bag for three minutes; increase above background should be $<10^{-7}$ sccs He. Record results:
